***Impacts to Stream Habitat and Wild Trout Populations in Vermont  
Following Tropical Storm Irene***

Vermont Fish and Wildlife Department Annual Report

**Study No. IX**            **Study Title:** Aquatic Habitat Conservation and Restoration

Period Covered: July 1, 2011 to June 30, 2012

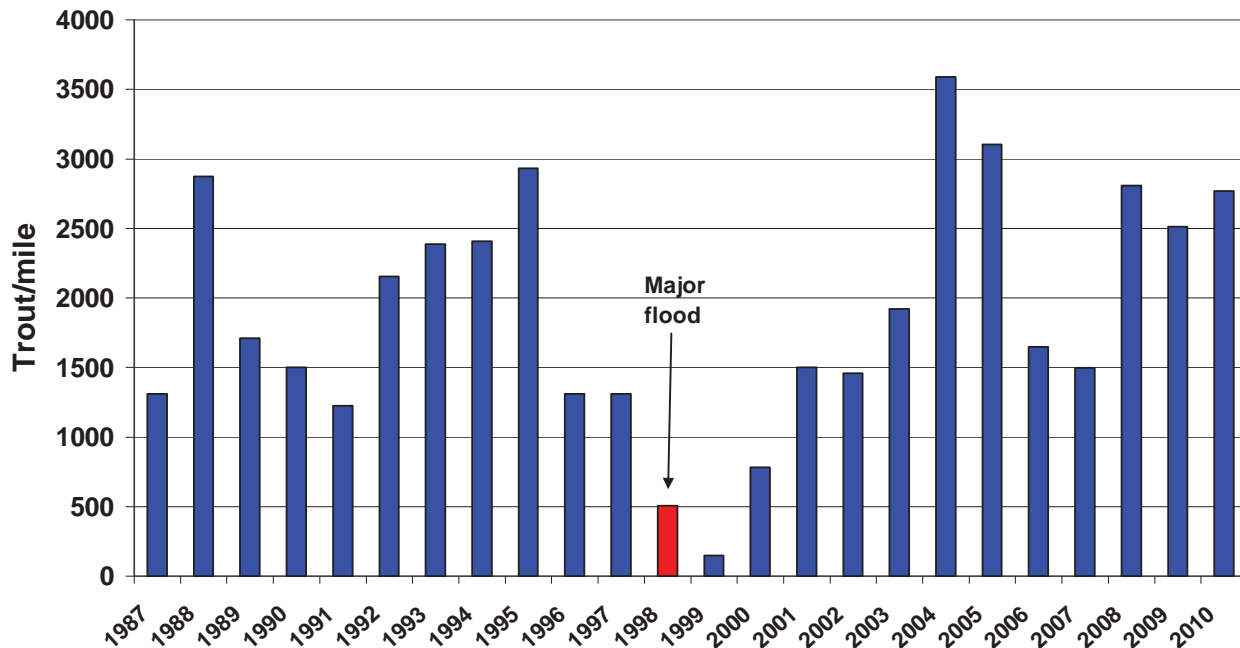
**Clay Brook** is a tributary of the Mad River and supports a fish population consisting exclusively of wild brook trout. Following the June 1998 flood event, brook trout populations dropped to their lowest levels in 11 years, totaling only 41% of the previous low recorded (Figure 2). A further decline in 1999 was recorded before recovery was apparent in 2000 while in subsequent years population levels were sustained at pre-flood levels.

**Figure 2. Clay Brook Wild Brook Trout Population Estimates**  
 Vermont Department of Fish and Wildlife Surveys  
 1987-2010

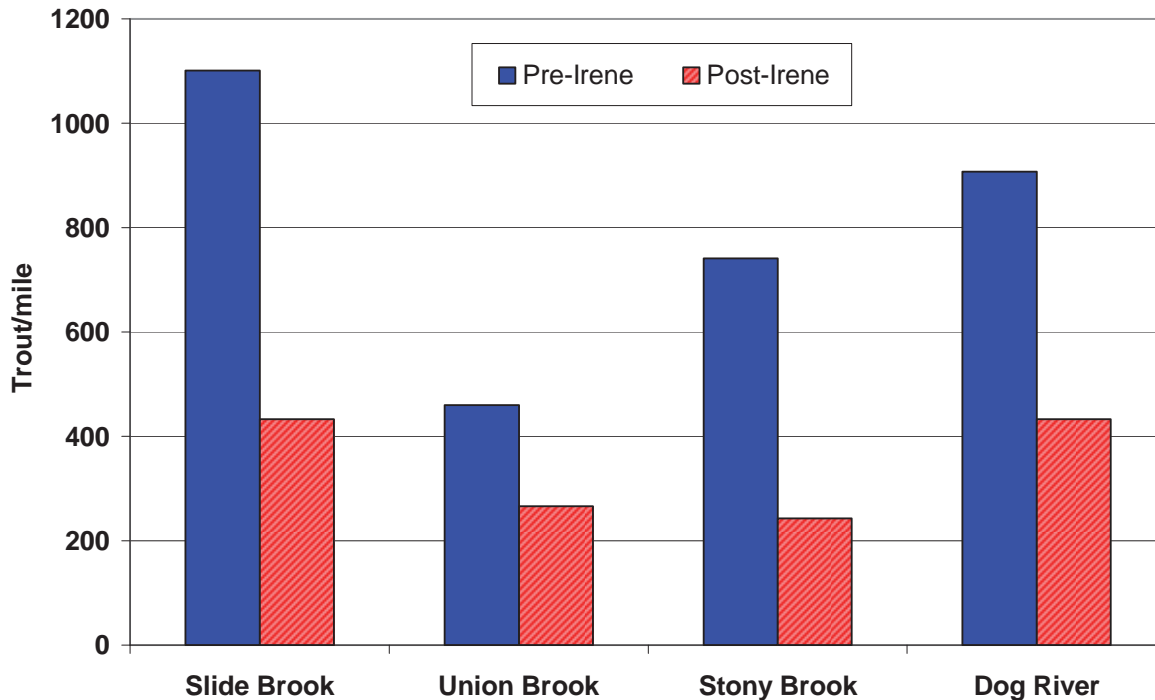
Several trout population surveys conducted in the Mad River and Dog River watersheds in 2011 prior to Tropical Storm Irene were repeated following the flood. Slide Brook is a tributary of the Mad River and supports wild brook trout. The upper Dog River supports wild brook trout as does its tributary, Union Brook. Stony Brook is also a tributary of the Dog River and supports both wild brook trout and rainbow trout. A comparison of pre- and post-flood population levels provides insight into the impact of flooding on wild trout resources in Vermont. As in previous extreme flood events, wild trout populations declined substantially. In the four streams surveyed, wild total trout population levels were reduced to 33-58% of pre-flood levels (Figure 4). Young fish were particularly affected (0-37% of pre-flood levels) while older trout fared better (41-64% of pre-flood levels). As in the previous examples, only limited post-flood channel alterations were conducted and despite significant movement of streambed material, these stream reaches maintained diverse and complex habitat conditions following the flood.

**Figure 4. Wild Trout Populations - Before and After Irene**  
Vermont Department of Fish and Wildlife Surveys

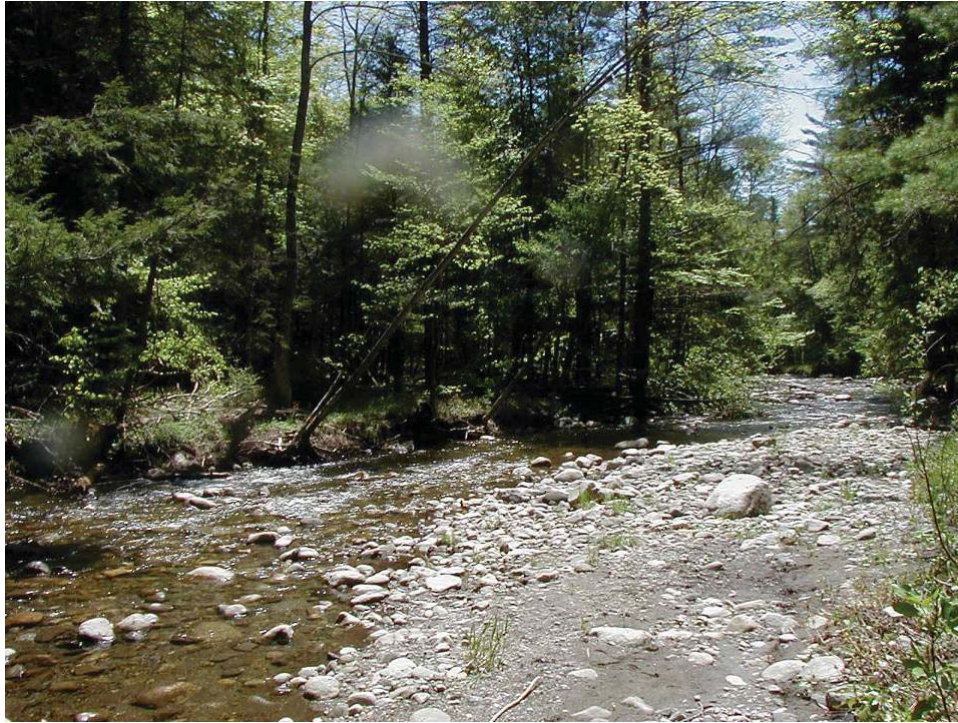
The photo below depicts a Vermont stream characterized by a variety of habitat types sustained by forested streambank vegetation, a variety of streambed substrates including natural wood, and a diversity of depths and velocities. In contrast, the lower photo shows the result of post-flood channel alteration activities where streambed material and natural wood has been removed and the channel is left over-widened and devoid of habitat complexity and diversity.

*Figure 5. A Vermont stream depicting complex and diverse habitat conditions.*

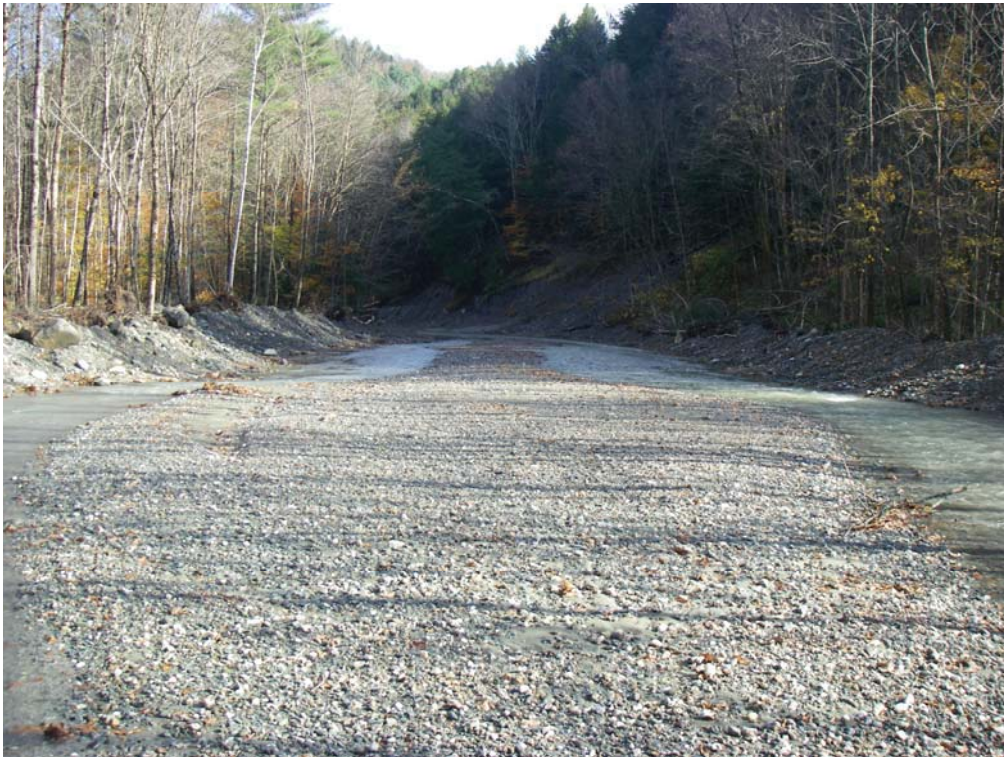
*Figure 6. Gilead Brook (Bethel) following extensive streambed and natural wood mining, berming and straightening after Tropical Storm Irene.*

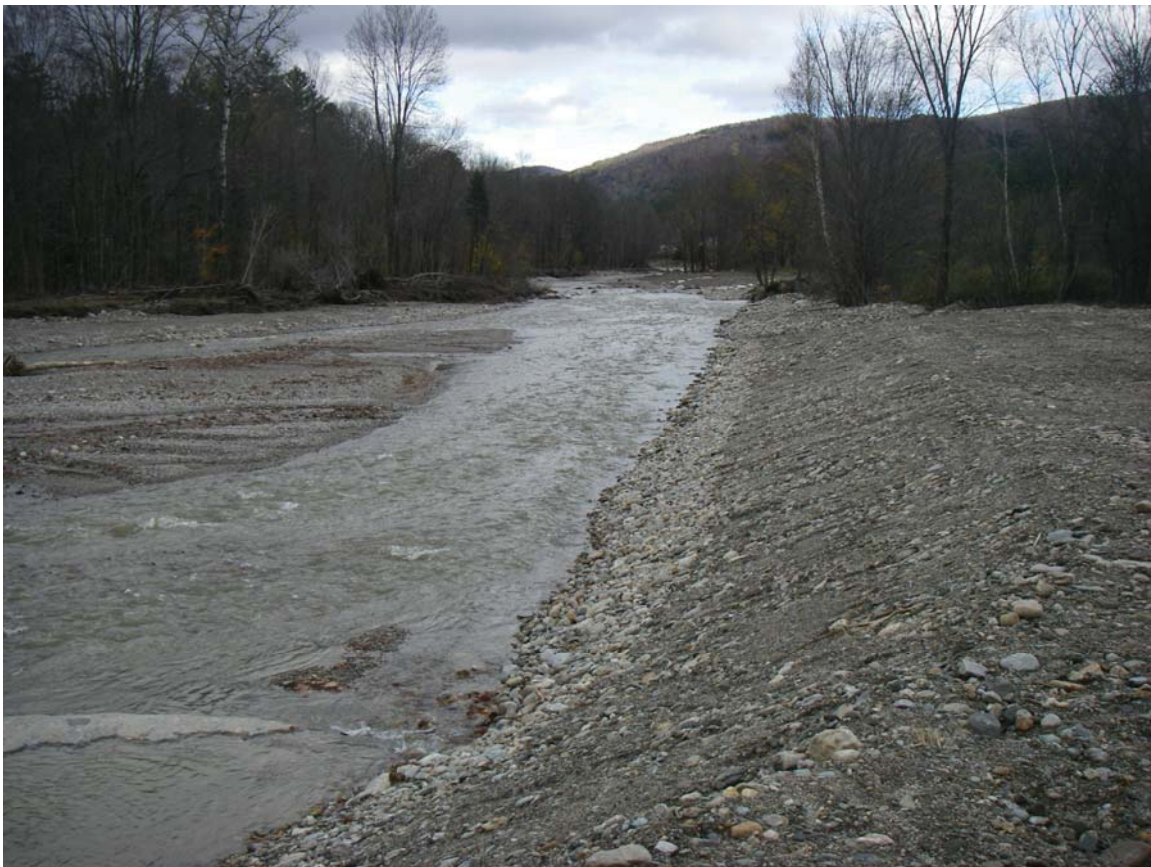
Where major impacts were recorded, stream channels were largely devoid of coarse streambed material and natural wood, and berming of streambanks or channel straightening may have also occurred. Figures 7 through 11 show examples of stream channel conditions during and after post-flood channel activities.

*Figure 8. The West Branch of the White River (Rochester) following streambed mining activities.*

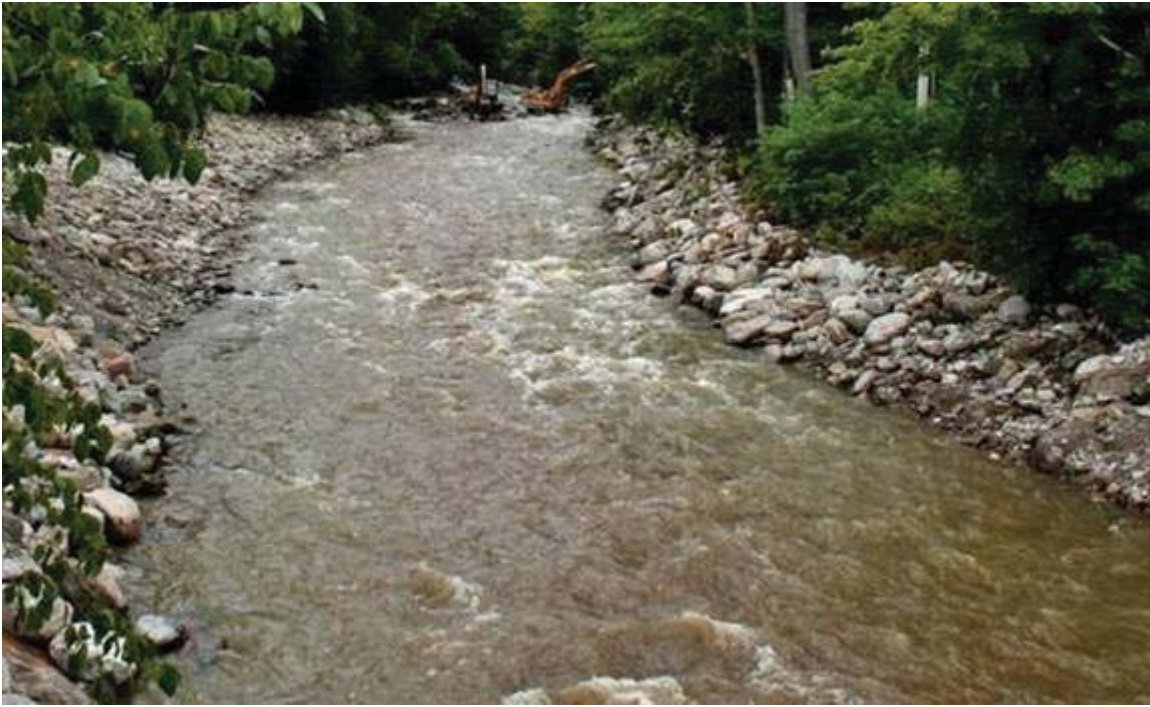
*Figure 8. The Middlebury River (Middlebury) showing excavators in the process of removing coarse material from the streambed and creating berms along the streambank.*

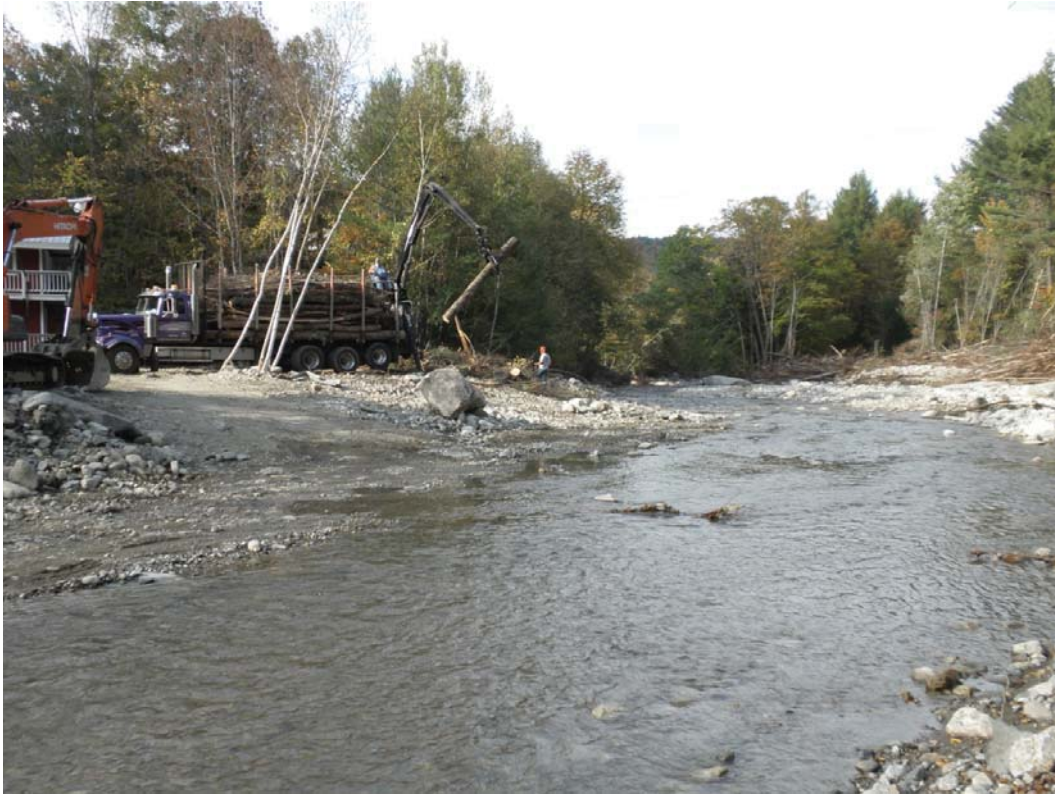
*Figure 10. Wardsboro Branch (Wardsboro) during a natural wood harvesting operation.*

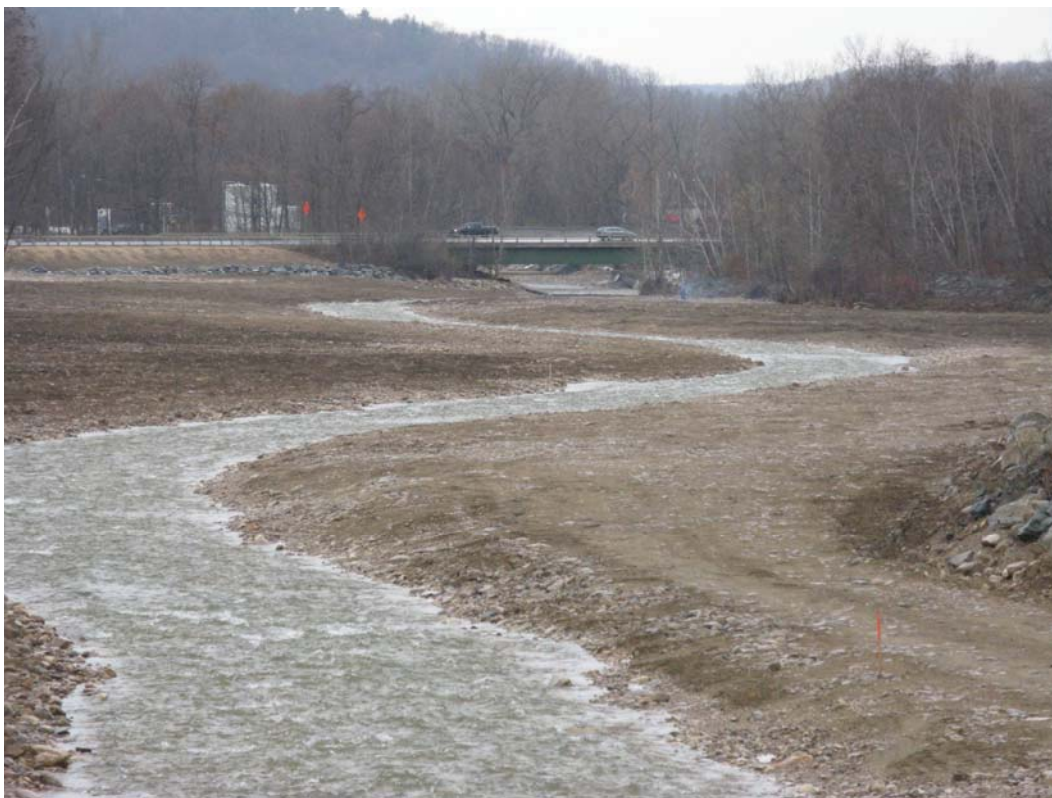
*Figure 11. An engineered stream channel of the Roaring Branch (Bennington) provides proper channel and flood plain dimensions, but is devoid of complex aquatic habitat features.*

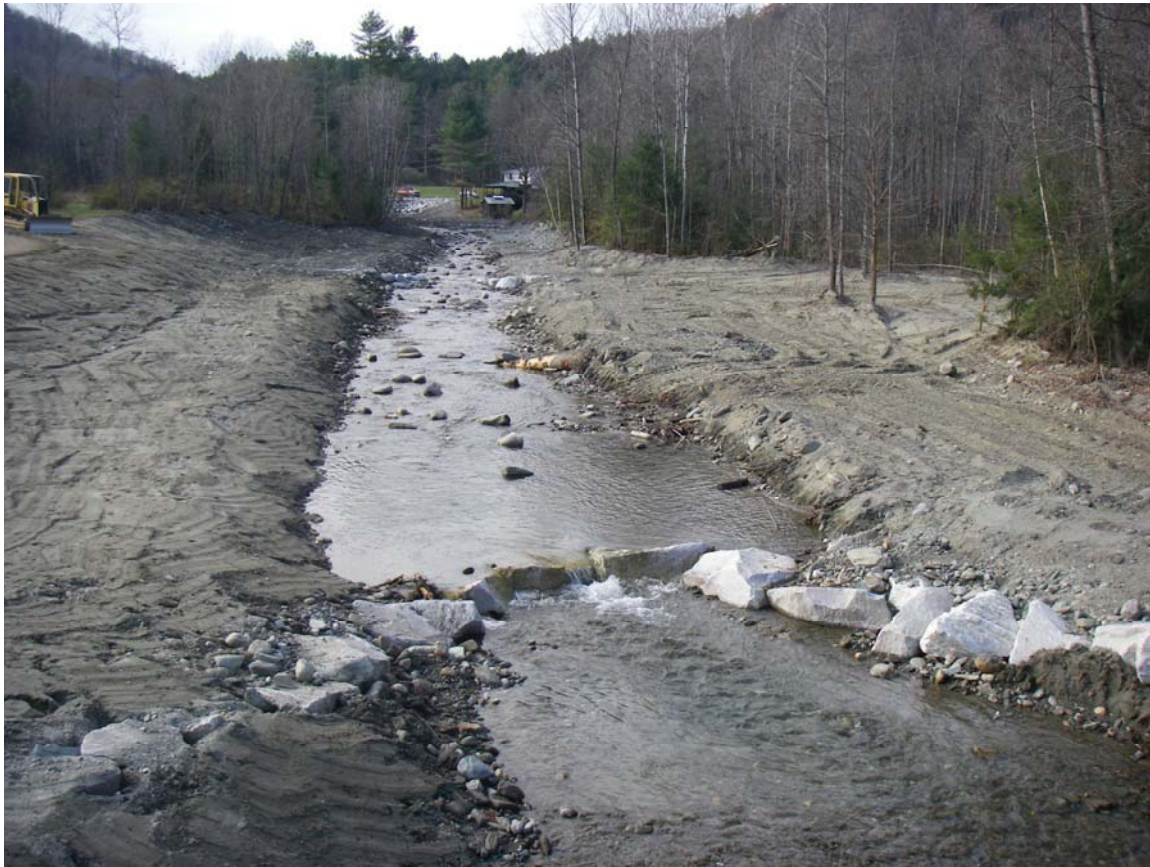
In a few cases, stream channel restoration was required as mitigation for excessive stream channel alteration. However, due to limited time, funding and available materials (coarse streambed substrate, natural wood); these efforts largely fell short of restoring aquatic habitat complexity (Figure 12).

*Figure 12. Camp Brook (Bethel) following instream channel restoration. Stream channel dimensions were improved but limited availability of materials precluded the restoration of aquatic habitat diversity and complexity.*
